# Manhole Inspection Summary

Manhole # S43EE\_014MH

Insp Date: **3/12/08 10:10 AM**

**Location** Address: **1213 BOND ST**

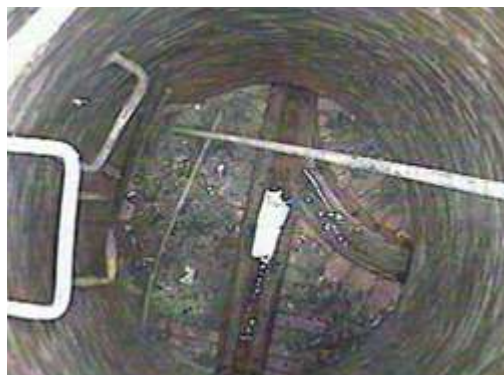
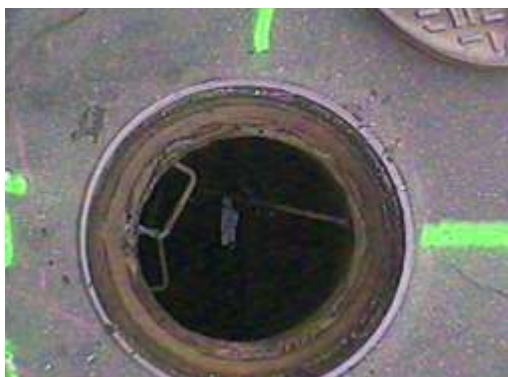
Top View

Shape: **Circular**

Condition: **Sound**

Condition: ☒ Sound ☐ Cracked ☐ Leaks

Condition: ☒ Sound ☐ Cracked ☐ Root Intrusion ☐ Loose Brick ☐ Deteriorated

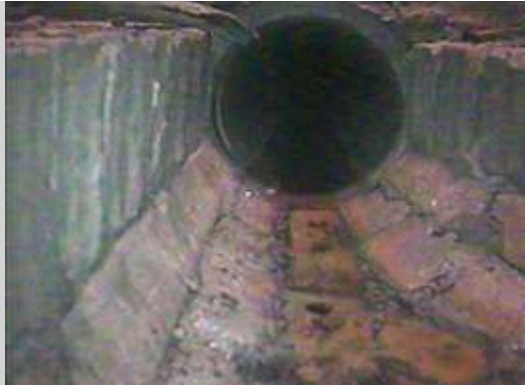
12 O'Clock Outflow

8 in. Circular Gravity Sewer  
Pipe Out @ 12 O'Clock

Pipe Height: (in.) Direct  
Pipe Material: **Clay** ☐ Pipe Lined  
Invert Depth: **9.31** (ft.) Flow Characteristics: **Slow**  
Deposits: ☒ None ☐ Mud ☐ Sludge ☐ Debris ☐ Grease  
Silt Depth: (in.) Deposits Extent:  
Infiltration: **None** Pipe Seal Cond: **Sound**

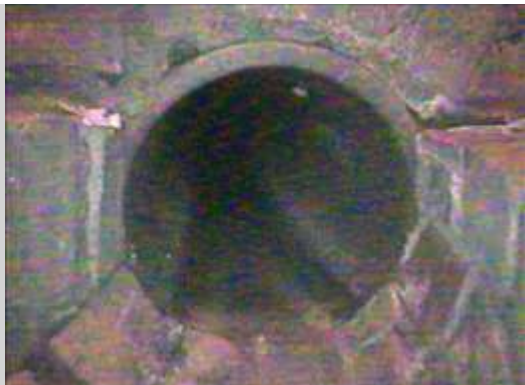
3 O'Clock Inflow

8 in. Circular Gravity Sewer  
Pipe In @ 3 O'Clock

Pipe Height: (in.) Direct  
Pipe Material: **Clay** ☐ Pipe Lined  
Invert Depth: **9.40** (ft.) Flow Characteristics: **Slow**  
Deposits: ☒ None ☐ Mud ☐ Sludge ☐ Debris ☐ Grease  
Silt Depth: (in.) Deposits Extent:  
Infiltration: **None** Pipe Seal Cond: **Sound**

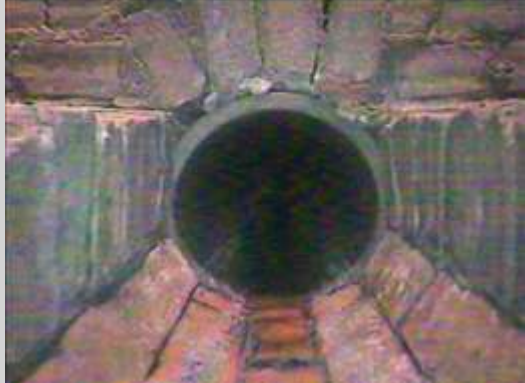
6 O'Clock Inflow

8 in. Circular Gravity Sewer  
Pipe In @ 6 O'Clock

Pipe Material: **Clay** ☐ Pipe Lined

Invert Depth: **9.35** (ft.) Flow Characteristics: **Slow**

Deposits: ☒ None ☐ Mud ☐ Sludge ☐ Debris ☐ Grease

Infiltration: **None** Pipe Seal Cond: **Sound**
